Stone Project No. 20211205 Subject: Hinesburg Landfill ID # CH280, Annual Landfill Inspection

Hinesburg Landfill

Hinesburg Closed Municipal Landfill 907 Beecher Hill Road, Hinesburg, Vermont

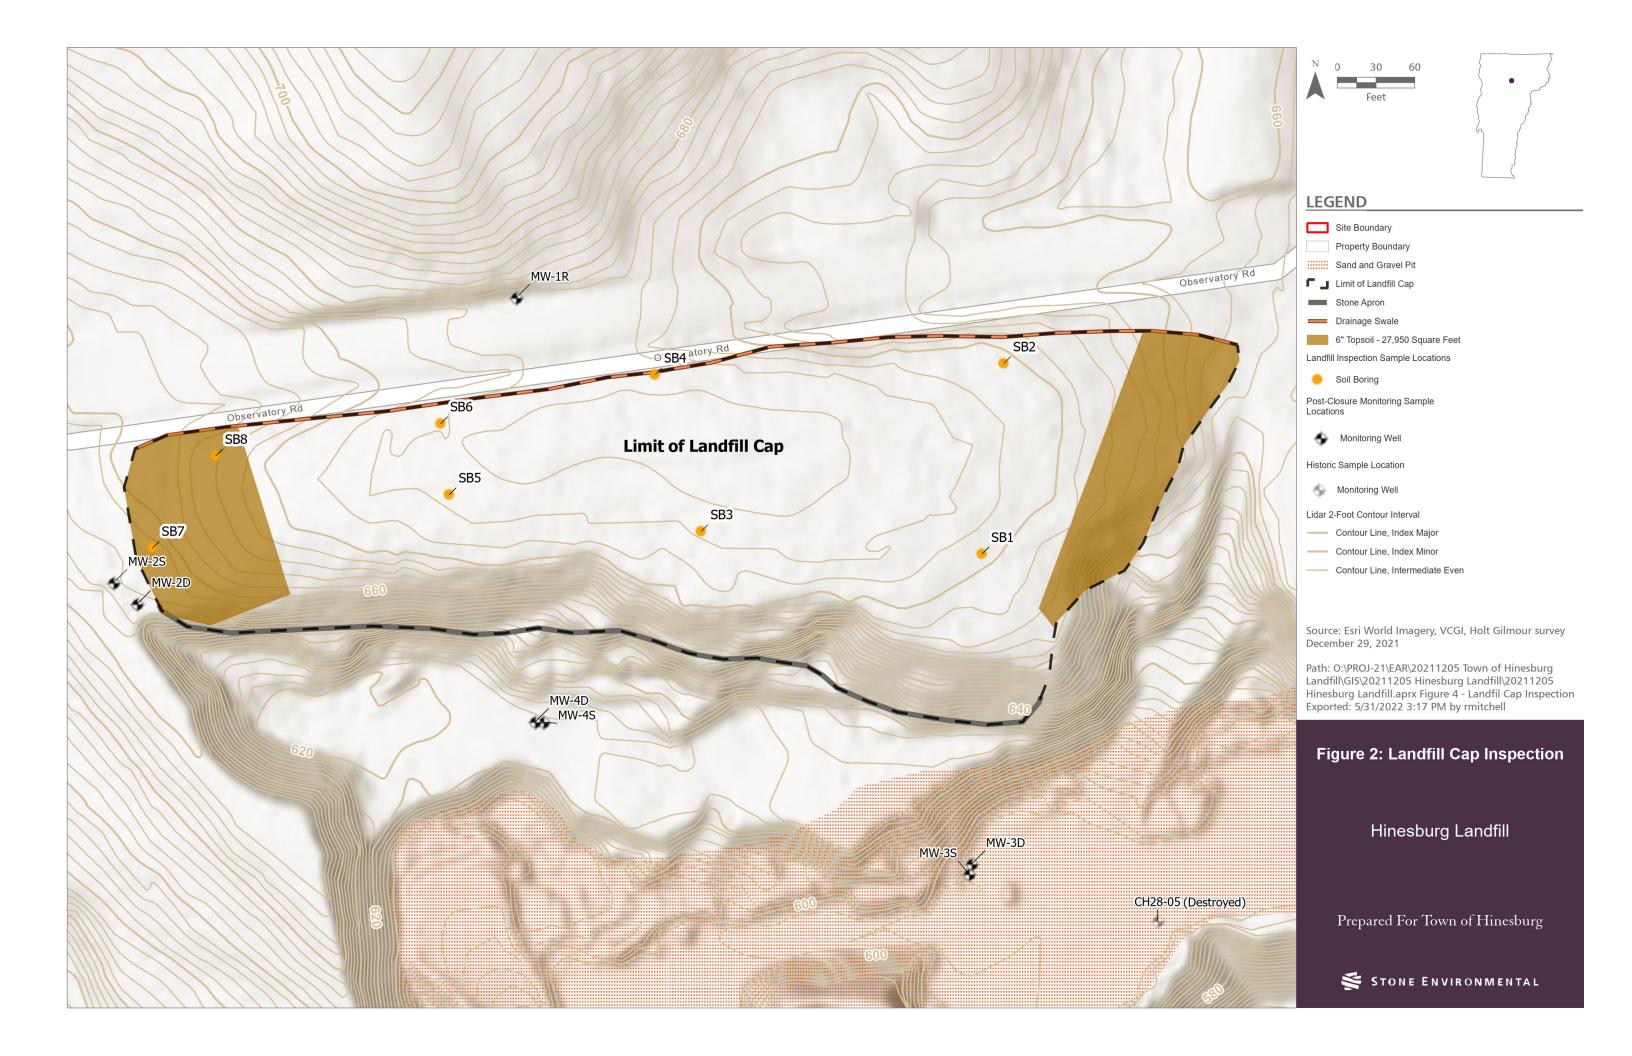
Based on the soil borings, Stone confirmed the extent of the landfill was as shown in the Closure Plan drawing titled Hinesburg Landfill Closure, and prepared by Donald L. Hamlin Consulting Engineers, Inc, dated October 9, 1990. Cover material was determined to not be adequate at locations SB-7 and SB-8, due to a lack of low permeability soils (silt or clay) and shallow depth to refuse and debris, observed at approximately 2 feet below ground surface.

- 1. The woody debris remaining from the tree removal shall be raked off the cover of the landfill. The stumps remaining from the tree removal shall be grinded between 4 and 6 inches below the ground surface.
- Six inches of topsoil and seed shall be placed in the eastern and western extent of the landfill (Figure 2) to properly cover refuse and debris and to promote vegetative growth. A native grass seed mix shall be used.

a. Prior to the addition of topsoil on the western extent, the uprooted tree stump shall be removed, and the cover material replaced within the root hole.

b. For the eastern extent, an erosion control blanket shall be placed on top of the seeded area due to a steep slope. The erosion control blanket will provide cover for bare soil and support for emergent vegetation from the time of seeding until root density and top growth are capable of long-term erosion protection.

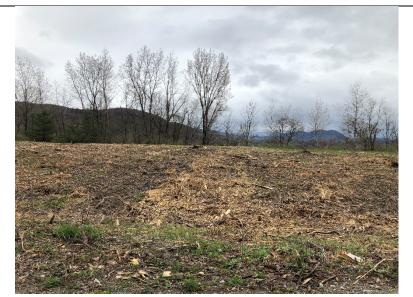
Photograph #1: Landfill cover with woody debris.

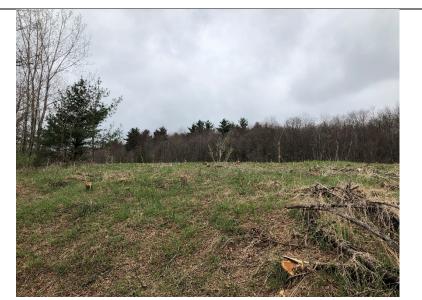
Photograph #3: View of adequate cover in central portion.
