AHEAD OF THE STORM

Site: LaPlatte Headwaters Town Forest

Location: Gilman Road, Hinesburg, Vermont

Existing Conditions Site Summary

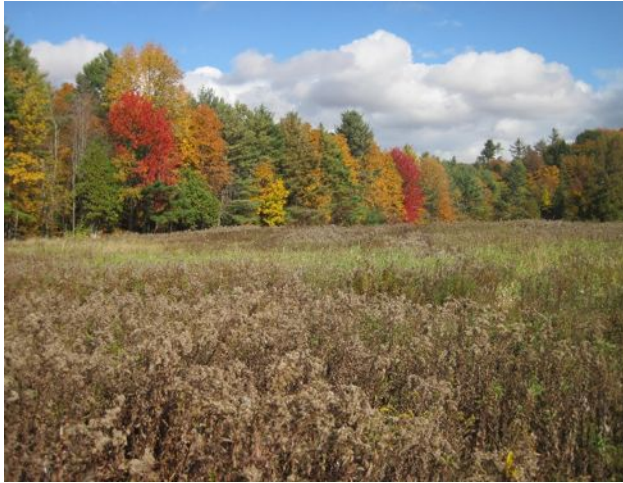
Figure 1: The hidden meadow is well vegetated and partially drains to the main gully.

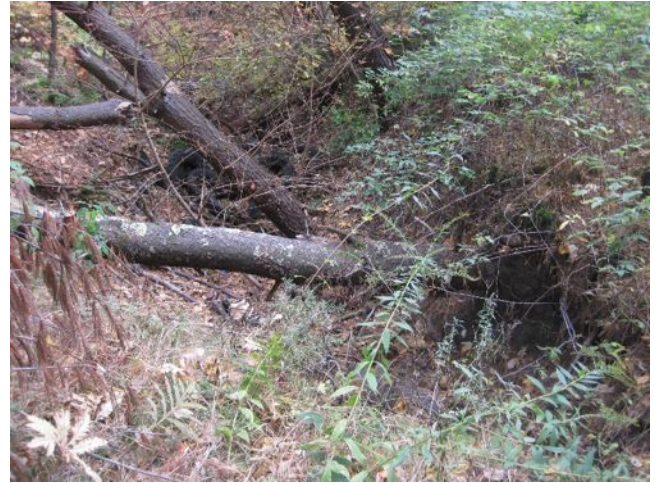
Figure 3: The upstream end of the gully has a headcut and changes elevation abruptly.

An estimated 800 tires were placed in the gullies to slow the flow of water and reduce the rate of erosion. It is believed that the tires were installed by a previous landowners in the 1970’s and 1980’s. The streambed has continued to erode since the tires were installed (LHTFMP, 2009). Headcutting upstream of the tires and erosion underneath the tires were observed in 2015. Observations by park uses indicate that the headcutting upstream of the tires has progressed upgradient 3-4 feet every year since 2005.

5. Place brush and logs in the upper gully to replicate the natural storage of sediment with wood.

Description: The upstream extent of the gully erosion has continued to move upgradient. It is recommended that brush and logs are placed in the upper gully to slow water and catch sediment. This will slow the rate of erosion. This technique replicates the natural storage of sediment. In the narrow upper section of the gullies volunteers can likely perform the labor by hand. Logs and brush could be accumulated from the forest during routine management. Examples of natural wood applications are included below that apply to this and the following recommendation. Wood was observed holding back sediment in the channel downstream of the gullies and can be used as an example (Photo 1). A nearby recent gully erosion repair project was completed using natural wood techniques that could be applied here (Photo 2). Typical engineering details of this type of natural wood application are found below including “Brush and Small Log Application”, “Log Stack Application”, and “Log Check Dam” (Figures 1, 2, and 3).

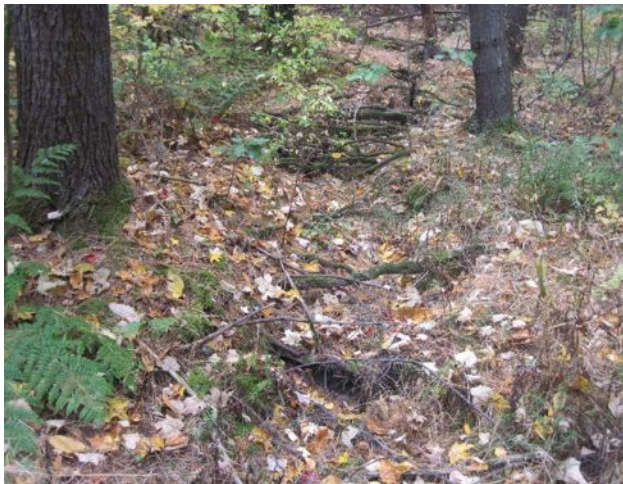
Figure 2: Upstream of the actively eroding gully top, a small channel is well vegetated and has a lot of roots.

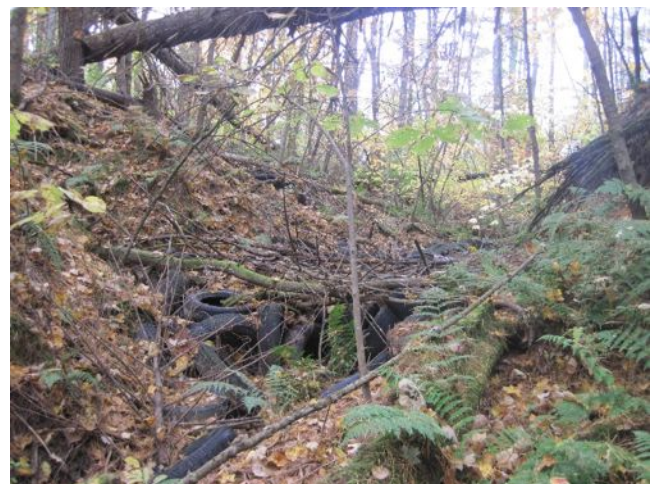
Figure 4: Tires have been dumped into the main gully.

4. Consider changing the LHTFMP High Priority Action to leave the tires in place and manage around them.

Description: The LHTFMP lists removal of the tires from the gullies as a High Priority Action. It is recommended that the committee consider the pros and cons of this action using information summarized in the above sections, based on the LHTF management goals. If the original basis of this Action was to improve water quality in the downstream receiving water, then the Committee should consider leaving the tires in place instead of disturbing the area and transporting the tires and their water quality impacts to another location. If the Action was to improve aesthetics, then the Committee should consider implementing one of the following restoration recommendations. If the Action was to remove non-natural materials from the LHTF, then the Committee should weight this against the impact of removal. If the ultimate decision is to remove the tires, then a safe disposal site would need to be located, a contractor would likely need to be hired to remove the tires, and significant stabilization would be required. Stabilization should be in the form of revegetation and natural log and brush structures, similar to recommendations in the following restoration recommendations.

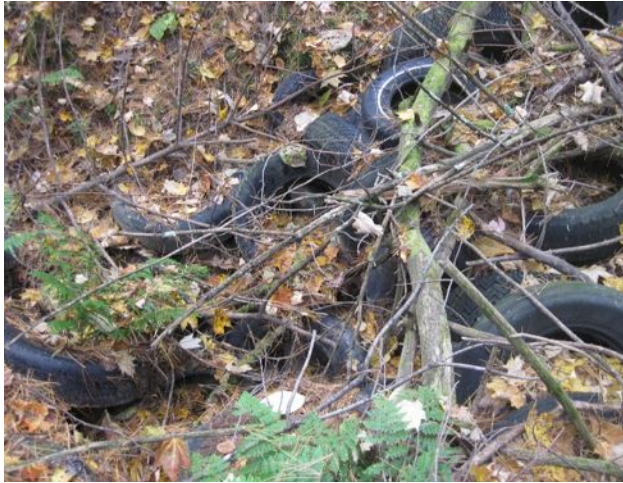
Figure 5: The tires are accumulating some sediment and debris in the gully.

Local wood, roots, and tires resist some erosion at the gully site. In some locations the tires are capturing sediment and debris. Material that is eroded may be permanently or temporarily captured in the downstream wetlands, connected forested floodplains, and in the slow water area created by the small culvert at Brookside Road. A portion of the sediment is likely transported to the LaPlatte River during floods.

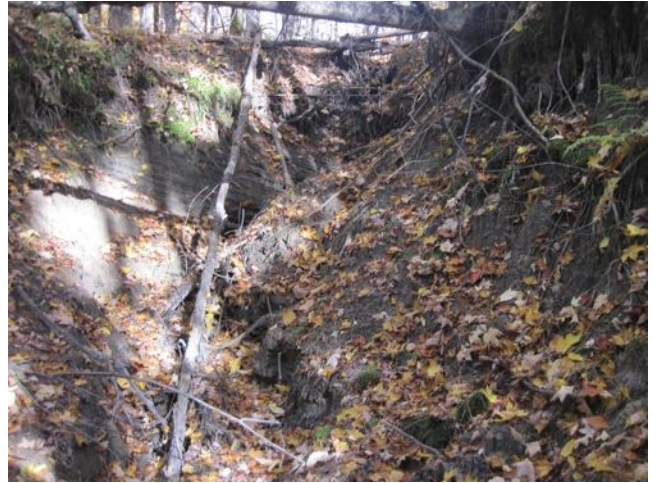
Figure 7: The side gully is not very long, but has steep, tall side slopes.

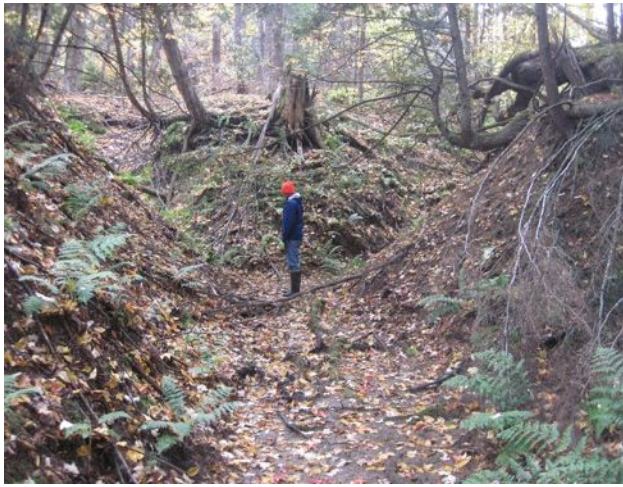
The gully erosion is occurring at the upstream end of a headwater tributary of the LaPlatte River within the LaPlatte Headwaters Town Forest Area near the Hidden Meadow. At the upstream end of erosion on the main gully, erosion begins with a 1 foot deep and 1 foot wide channel. This area is well vegetated. Just downstream of where the gully begins the erosion is 5 feet deep and 10 feet wide, this quickly transitions to a gully almost 30 feet wide and over 10 feet tall. Approximately 800 tires have been thrown into the gully in an effort to stop the erosion. Approximately 400 feet down the main gully a side gully joins from the east. The side gully is up to 17 feet tall and 40 feet wide. Both gullies are actively eroding.

Figure 6: A side gully enters the main gully.

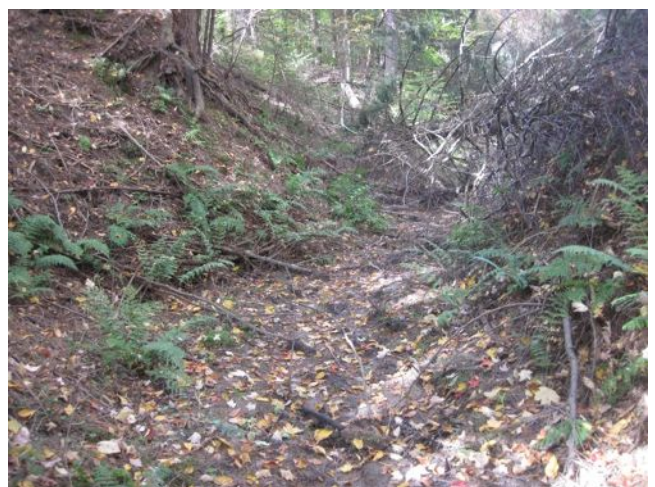
Downstream of the steep eroding section of gully, the valley walls were stable with approximately at 2H:1V slope with limited erosion at the toe. At this point a stream channel formed and water was present. Further downstream the valley opened up into a flat open wetland. Perennial vegetation covered the floodplain with small sediment deposition piles. The channel then became more defined and entered a forested area further downstream. The channel sinuosity increased and passed through a white cedar swamp. Then the channel passed through a 3-foot diameter driveway culvert at Brookside Lane. This culvert was in poor condition. The small size of the culvert likely would provide in-channel stormwater attenuation and allow sediment to settle out of slowed runoff. Downstream of Brookside Lane the channel is flows through a wetland meadow (Rosgen type E) and joins the LaPlatte River.

Figure 8: The channel downstream of the gully has little erosion on the banks.

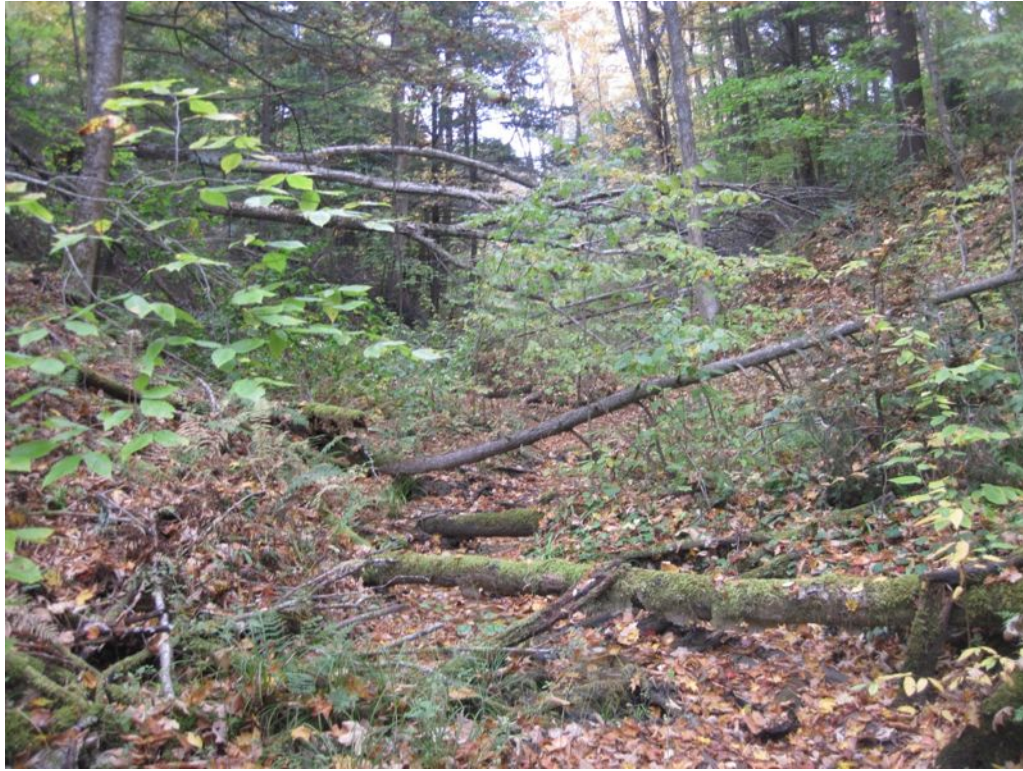
Photo 1. Logs across the downstream channel are stabilizing the channel bed and catching sediment and debris.
