**Ecological Restoration in the LaPlatte Headwaters Town Forest:  
Understanding impacts and developing management strategies related to Beavers**

Rubenstein School of Environment and Natural Resources, University of Vermont  
NR 206: Environmental Problem Solving and Impact Assessment  
Professor Dave Kestenbaum  
May 5, 2021

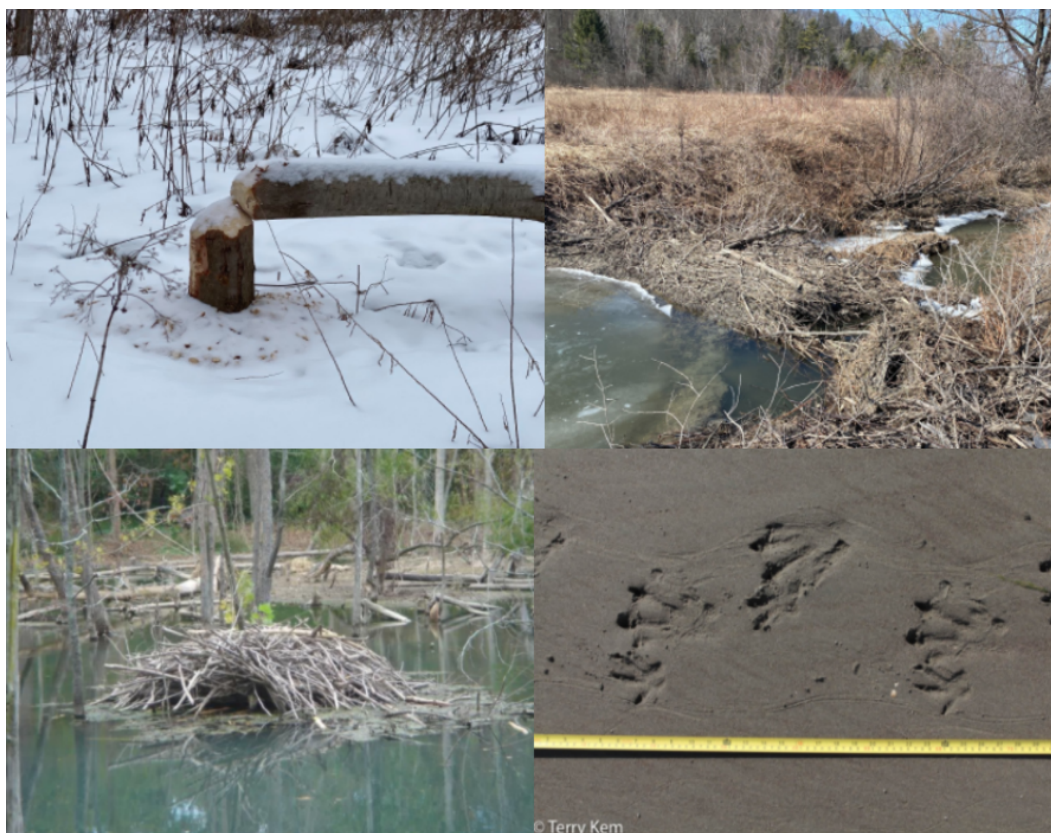
Figure 2: Images of the distinctive "pencil points" (top right), a beaver dam (top left), a beaver lodge (bottom left), and beaver tracks (bottom right). Top right and left are images taken at LHTF.

Beavers build dams to create deep ponds that do not freeze at the bottom in winter. Within or beside these constructed ponds, they build "lodges" to provide protection for their young in summer and for the entire colony in winter. There are two main types of lodges, the conical lodge and the bank lodge. The conical lodge is completely surrounded by water. The walls of the conical

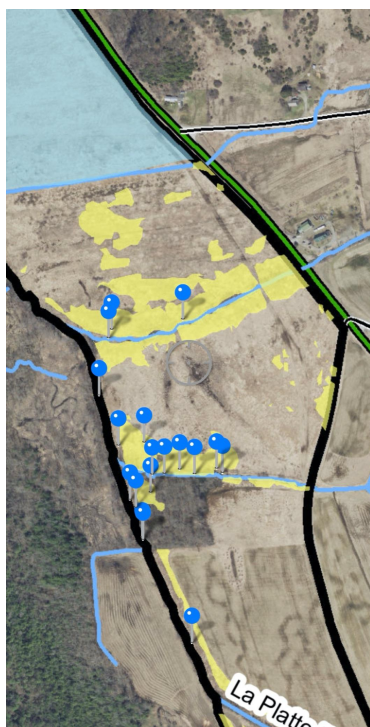
Figure 8: Central, Blue Pins represent beaver activity. Beaver activity includes dams, lodges, and chewed trees.

Below that section, another stream (Figure 6, stream 3) curves from the western boundary to cut east across the property. This part of the river is *heavily* populated by beaver dams and fallen trees along the banks. As of the last visit two thick, freshly downed trees can be found near the bend. This appears especially vulnerable to potential flooding from beaver activity.

Following the river further south along the western boundary a few points of beaver activity can be found, with the beginnings of a dam and some tree chewings present. This area is right along the property boundary of 1067 Silver St. If activity here were to increase then some management strategies would need to be used to minimize flooding onto the property of 1067 Silver St.

The river bends one last time from the western boundary east across LHTF on the lower edge of the Central portion, creating a line between the central and south central survey sections. (Figure 8) There are almost no signs of beavers in this part of the stream.
