AHEAD OF THE STORM

Site: LaPlatte Headwaters Town Forest

Location: Gilman Road, Hinesburg, Vermont

Existing Conditions Site Summary

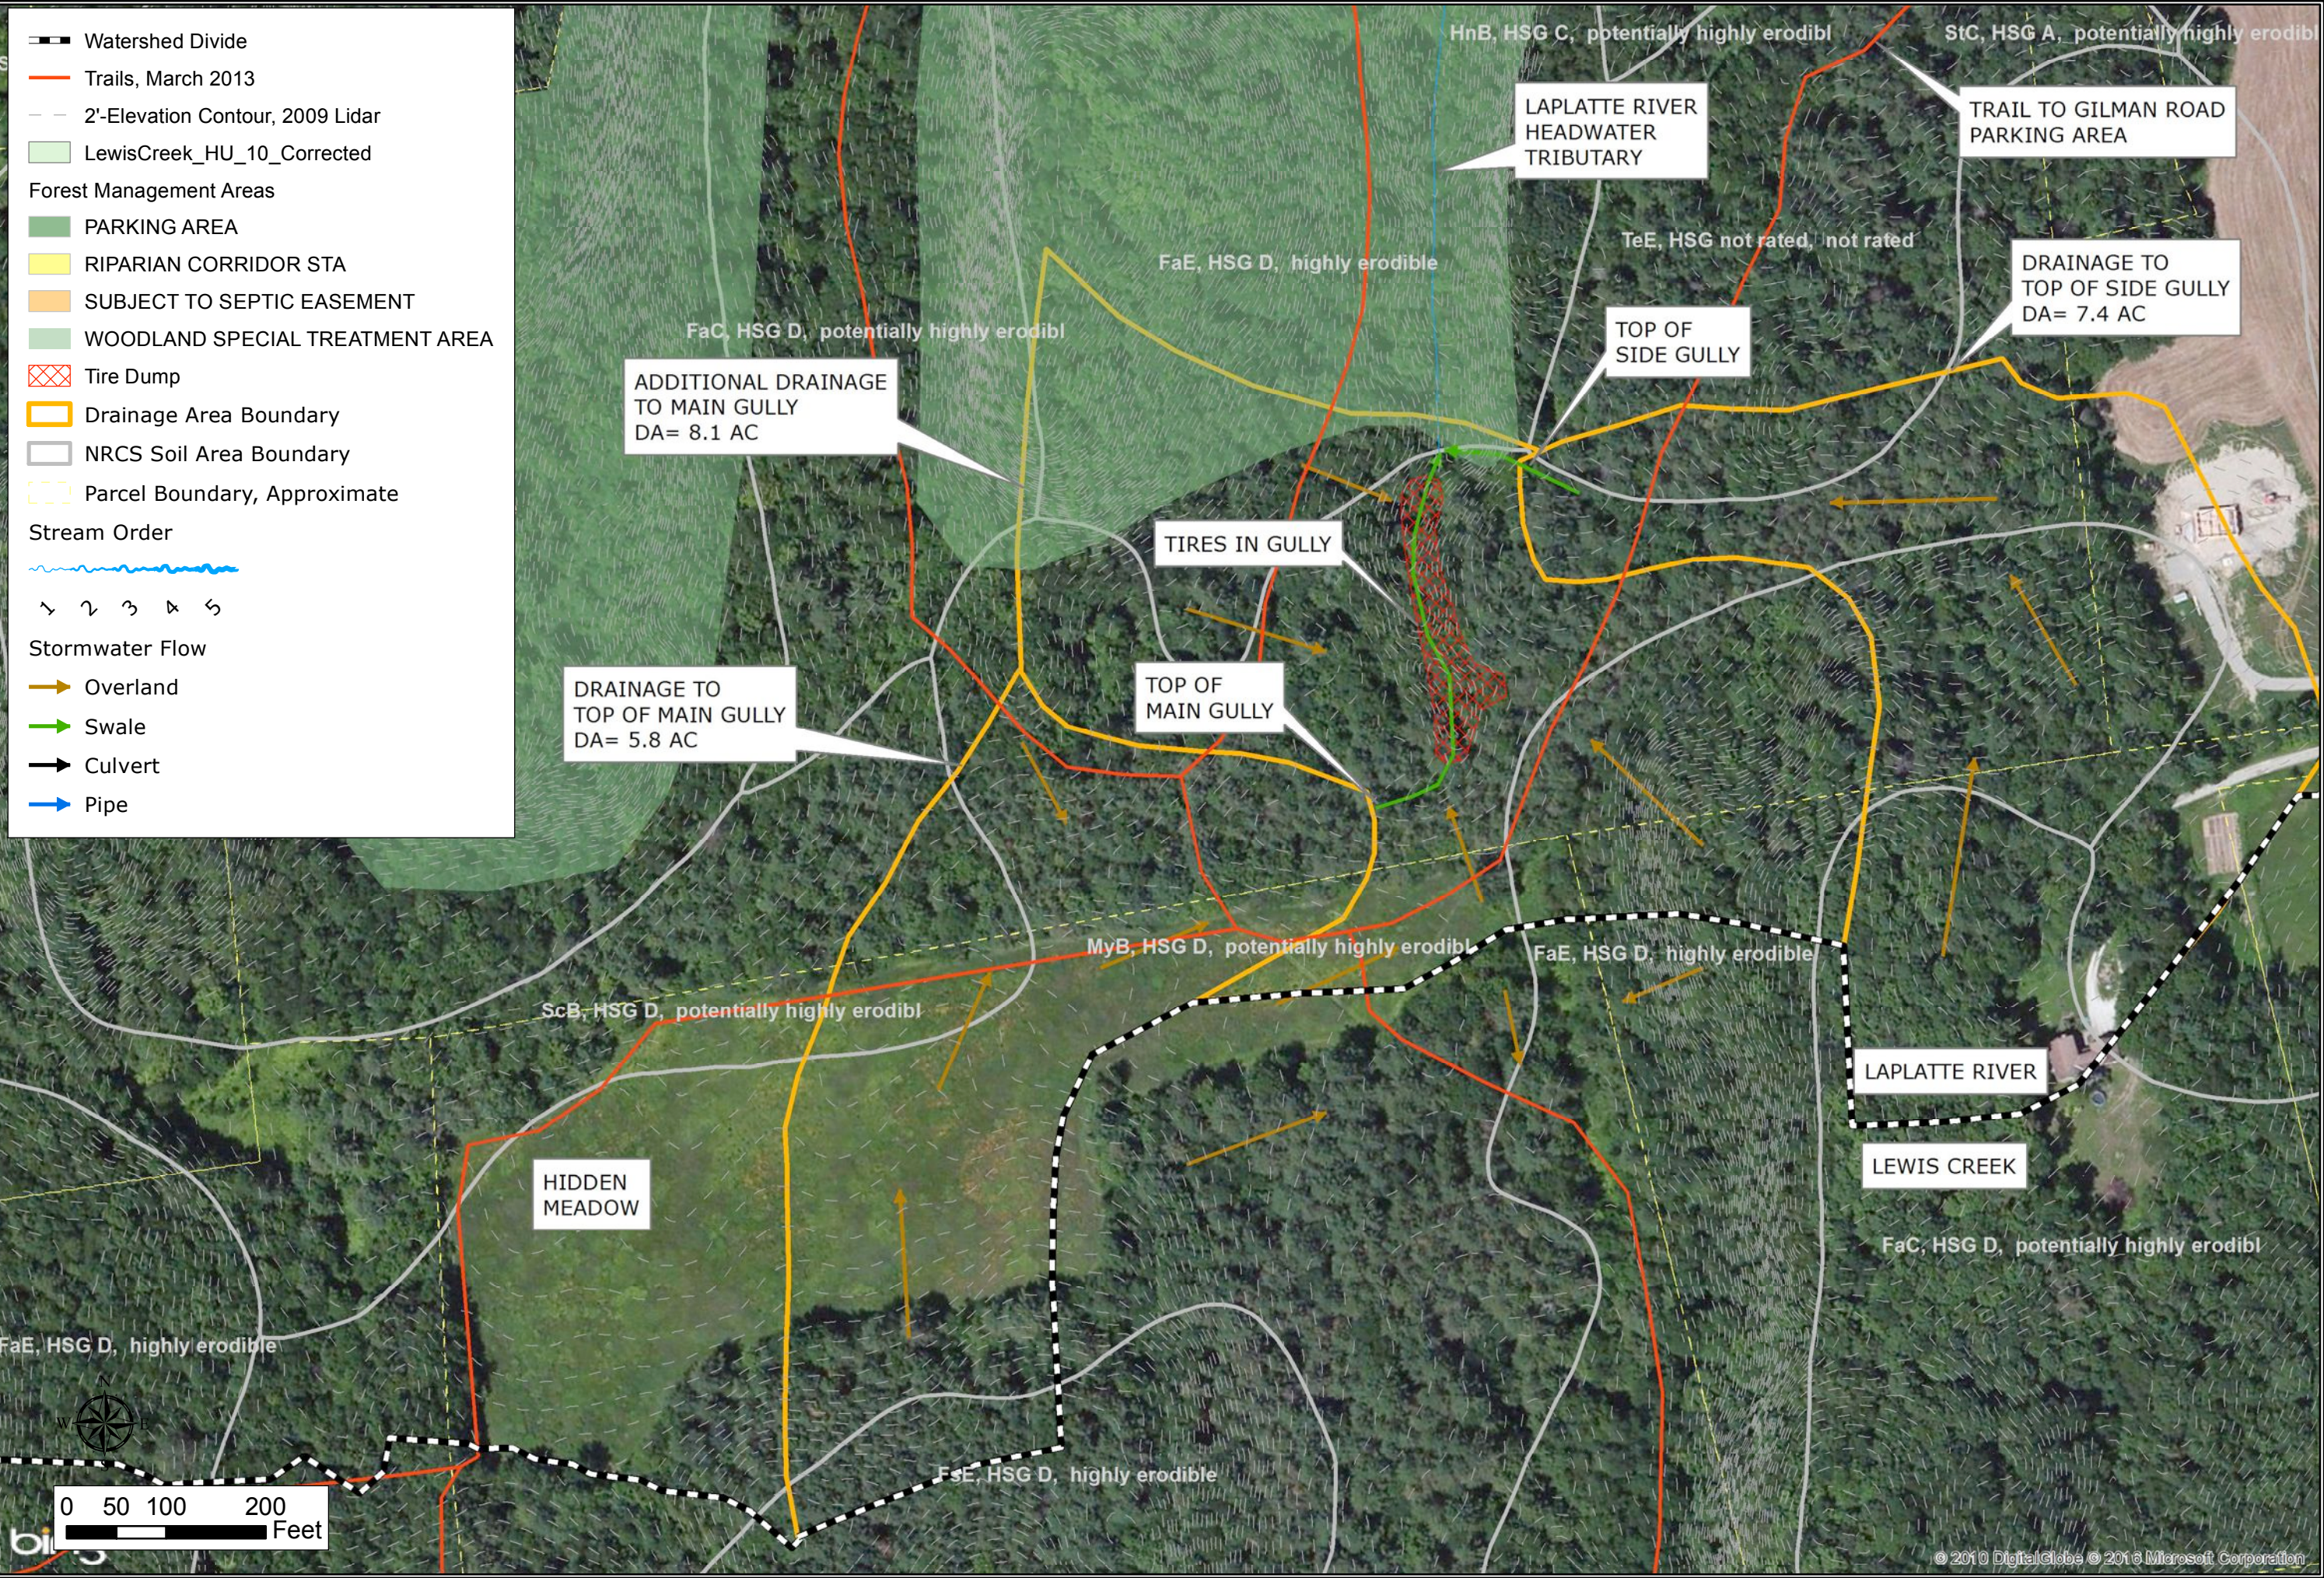
Gully erosion is occurring in several areas of the LaPlatte Headwaters Town Forest Area, specifically at the upstream end of two branches of a headwater tributary of the LaPlatte River. The gully erosion and headcutting are likely caused by increases in runoff from historic changes to land use associated with farming and clearing the land between the 1800's and mid-1900's. This may have also been influenced by channel incision in the downstream LaPlatte River and subsequent tributary regeneration (incision of the tributary to match the new elevation of the receiving stream base elevation). Increased rainfall intensity and magnitude may also have led to the expansion of minor initial erosion to the larger erosion observed today. Many years ago car tires were thrown into the gully to stop the erosion. This project created a management plan for the gully erosion to improve water quality and flood resilience. *(See existing conditions site summary and plan.)*

Gully erosion is occurring in several areas of the LaPlatte Headwaters Town Forest Area (Figure 1). The erosion was first discovered due to a conflict with one of the Hinesburg Area Recreation Trails (Bissonette Loop) that has since been relocated away from the head of the gully. This project will advise on management of the erosion to improve water quality and flood resiliency.

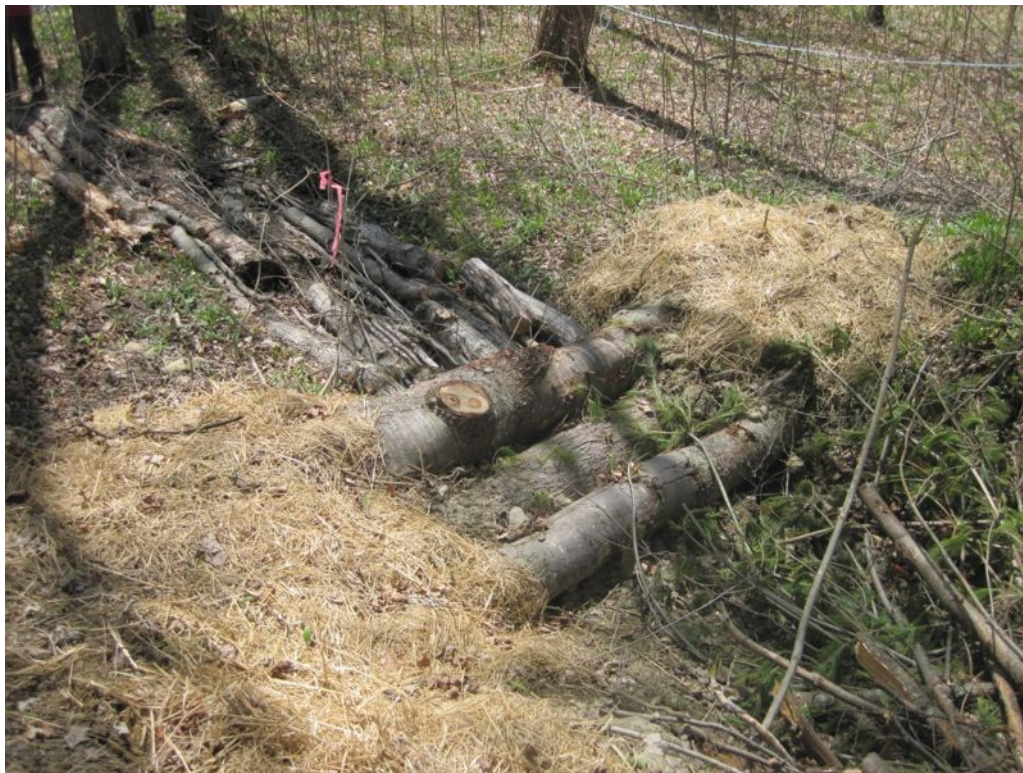
Photo 2. Example of log check dam and brush and small log application at gully erosion site adjacent to Pond Brook in Monkton, Vermont. This photo was taken at time of installation, prior to accumulation of sediment between the logs and brush.

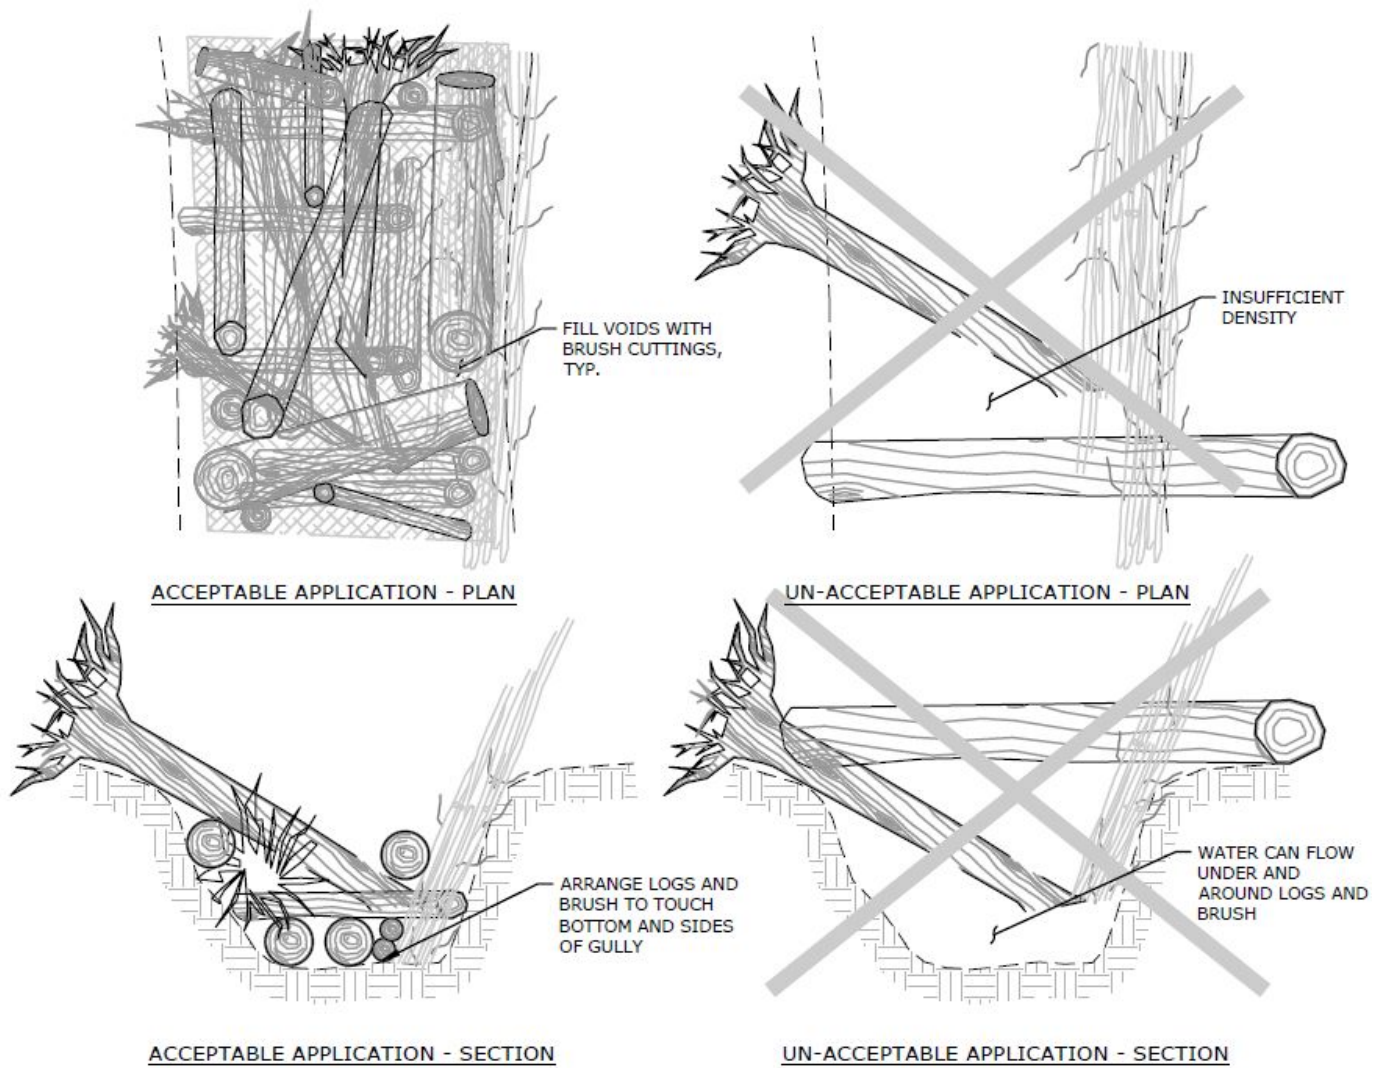
BRUSH AND SMALL LOG APPLICATION

Figure 1: Typical detail of natural gully stabilization technique, Brush and Small Log Application.

Description: The upstream extent of the gully erosion has continued to move upgradient. It is recommended that brush and logs are placed in the upper gully to slow water and catch sediment. This will slow the rate of erosion. This technique replicates the natural storage of sediment. In the narrow upper section of the gullies volunteers can likely perform the labor by hand. Logs and brush could be accumulated from the forest during routine management. Examples of natural wood applications are included below that apply to this and the following recommendation. Wood was observed holding back sediment in the channel downstream of the gullies and can be used as an example (Photo 1). A nearby recent gully erosion repair project was completed using natural wood techniques that could be applied here (Photo 2). Typical engineering details of this type of natural wood application are found below including “Brush and Small Log Application”, “Log Stack Application”, and “Log Check Dam” (Figures 1, 2, and 3).

1. INSTALL SMALL LOGS AND BRUSH IN CHANNEL TO STOP EROSION, SLOW FLOW, AND CATCH SEDIMENT.
2. CUT LOGS TO FIT AND FILL THE CHANNEL, EXPECTED LENGTH IS 4' TO 6' LONG. THIS WILL REQUIRE TURNING PIECES AND STACKING SO THAT INDIVIDUAL PIECES FIT DOWN INTO CHANNEL AND TOUCH THE BOTTOM.
3. FILL VOIDS WITH BRUSH CUTTINGS.
4. INSTALLATION IS EXPECTED WITH CHAINSAW AND HANDWORK.
5. USE EXISTING DOWNED WOOD WHERE POSSIBLE.
6. WHERE NEW CUT WOOD IS REQUIRED CONSULT WITH LANDOWNER AND FOREST MANAGEMENT PLAN.

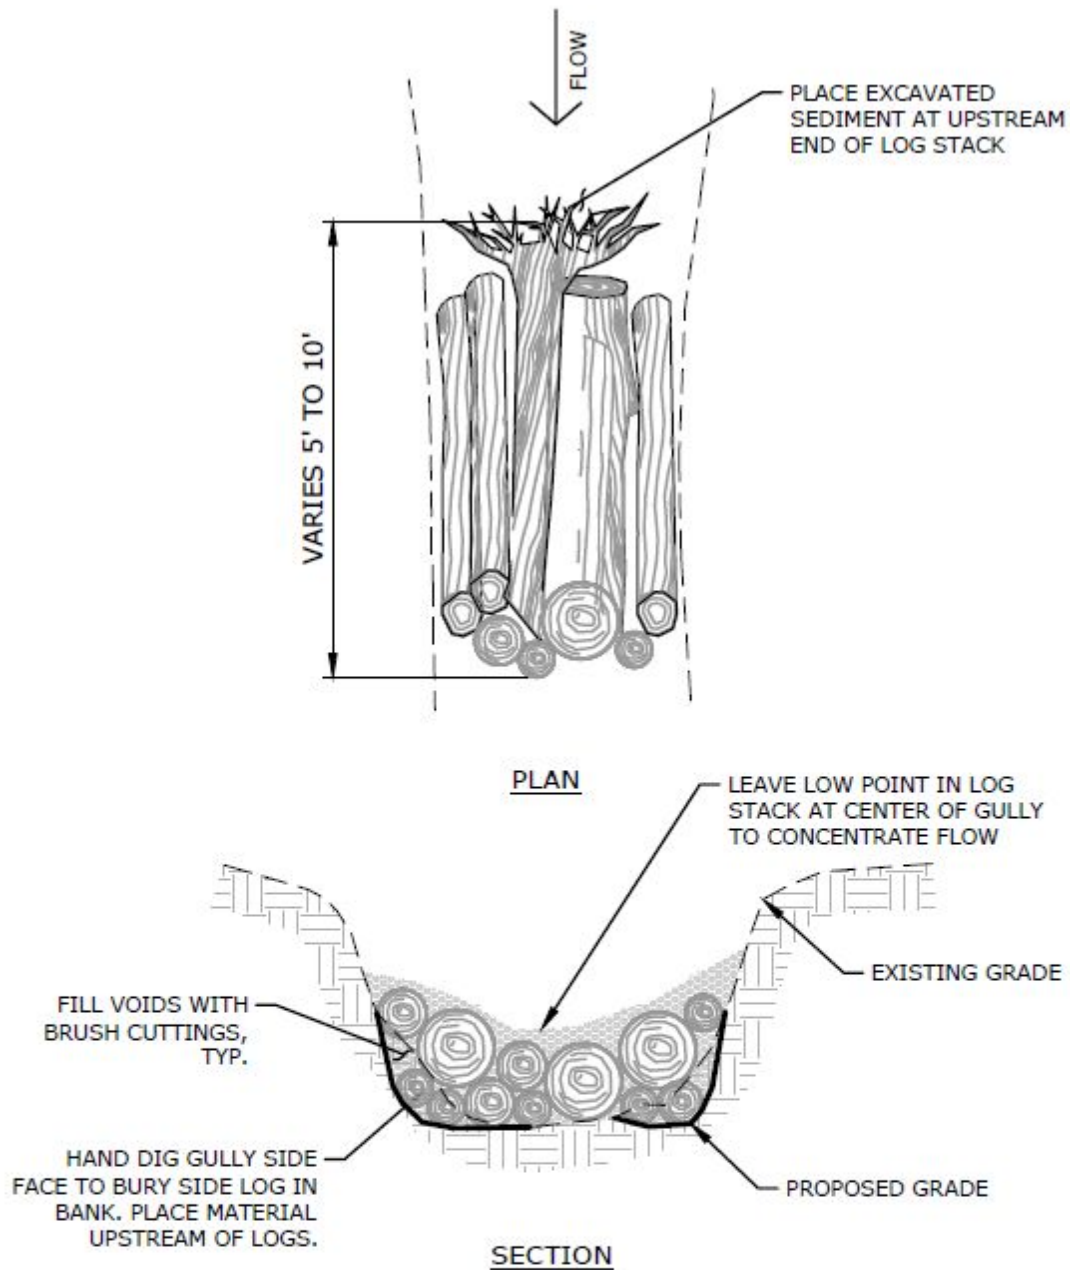
LOG STACK APPLICATION

Figure 2: Typical detail of natural gully stabilization technique, Log Stack Application.

1. INSTALL SMALL LOGS AND BRUSH IN CHANNEL TO STOP EROSION, SLOW FLOW, AND CATCH SEDIMENT.
2. STACK LOGS AND FILL VOIDS WITH BRUSH SO THAT INDIVIDUAL PIECES FIT DOWN INTO CHANNEL AND TOUCH THE BOTTOM AND VOIDS ARE FILLED.
3. INSTALLATION IS EXPECTED WITH CHAINSAW AND HANDWORK.
4. USE EXISTING DOWNED WOOD WHERE POSSIBLE.
4. WHERE NEW CUT WOOD IS REQUIRED CONSULT WITH LANDOWNER AND FOREST MANAGEMENT PLAN.
